LOW ALTITUDE LIGHTNING ATTACHMENT TO AN AIRCRAFT

P. L. RUSTAN, B. P. KUHLMAN, AND H. D. BURKET
Flight Dynamics Laboratory (AFWAL/FIESL)
Wright-Patterson AFB, Ohio 45433-6553

May 1987

Interim Report for Period October 83 - February 85

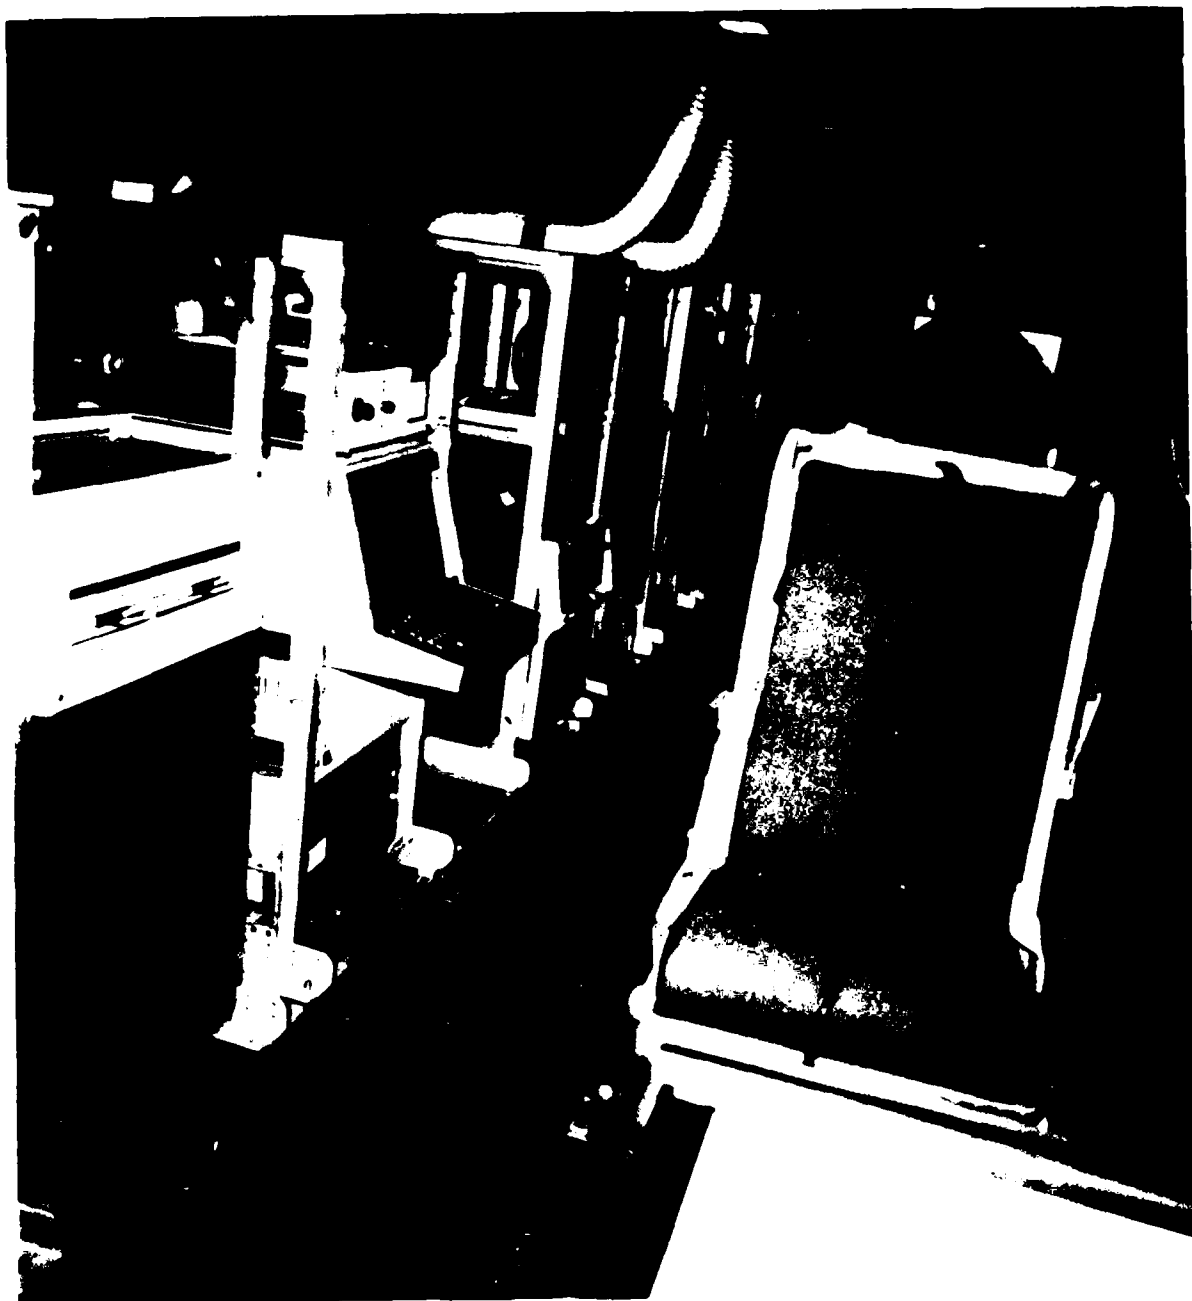
Figure 14. CV-580 Aircraft Rack Layout

Figure 14 shows a view of the instrumentation layout inside the aircraft. The first rack on the left hand side of Figure 14 contains a video cassette recorder to store the data from one of the cameras, a floppy disk unit used for programming and auxiliary storage of data, and a Cypher 9-track magnetic tape recorder which was used to store the digital data. The second rack contains a TV monitor for the video cameras, the Stormscope display unit, a data display CRT unit, the computer CRT and keyboard used for program and control, and a hard copy machine used to print the digital data stored on the 9-track tape recorder. The third rack contains a power switching unit, the time code unit, and the PDP 11-35 computer main unit. The fourth rack contains three of the 7612D waveform digitizers used to acquire the digital data. Figure 15 shows the fifth, sixth, and seventh racks as mounted on the right hand side. The fifth rack contains the signal conditioning panel, the set of digiswitches used to set the triggering threshold level of the various sensors, and two of the digitizers. The sixth rack contains the Data Logger System with four digitizer and recording capability and a 7612D waveform digitizer. The seventh rack contains the Honeywell 101 28-channel analog recorder with all the reproduce channels. The last rack was used to process
